TREC Technical Report 60-54

YHC-1B U. S. ARMY "CHINOOK" MOCKUP EVALUATION
Morton, Pennsylvania
27 January 1960

REPORT OF CRASH INJURY EVALUATION
AvCIR-13-PV-118
September 1960

VERTOL YHC-1B U. S. ARMY "CHINOOK"

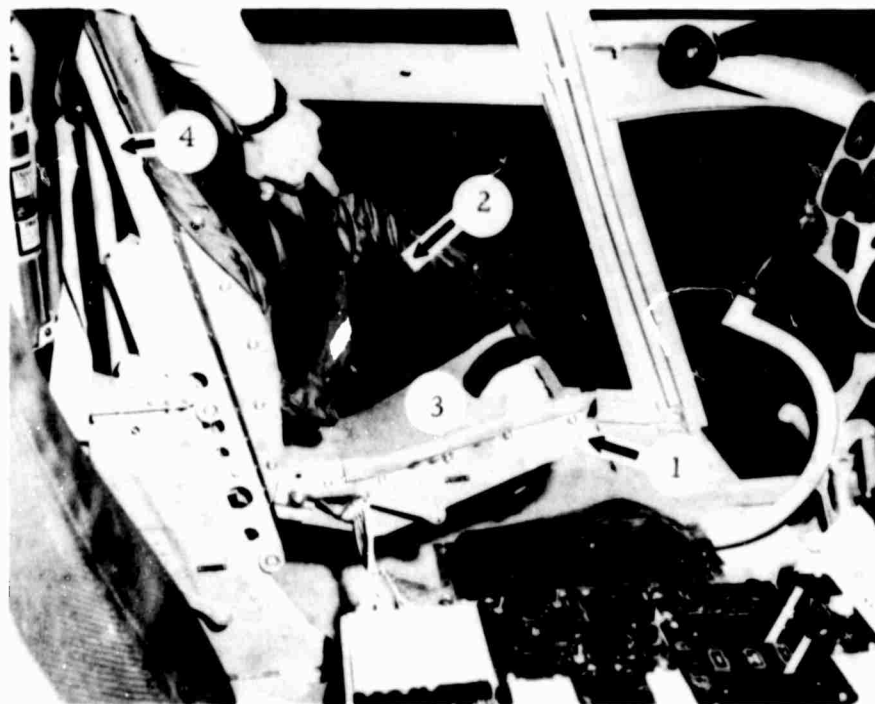
It has been designed for a crash landing load factor of 8 G longitudinally, 8 G vertically and 8 G laterally, acting separately. Although no physical tests (static or dynamic) have been conducted on the seat as a whole, at the time of this writing, preliminary stress and load analyses have been made to insure that the 8 G design requirements will be met.

Figure 14. Copilot's seat. Seat pan (1); seat cushion material (2); foam rubber padding (3); seat back (4).

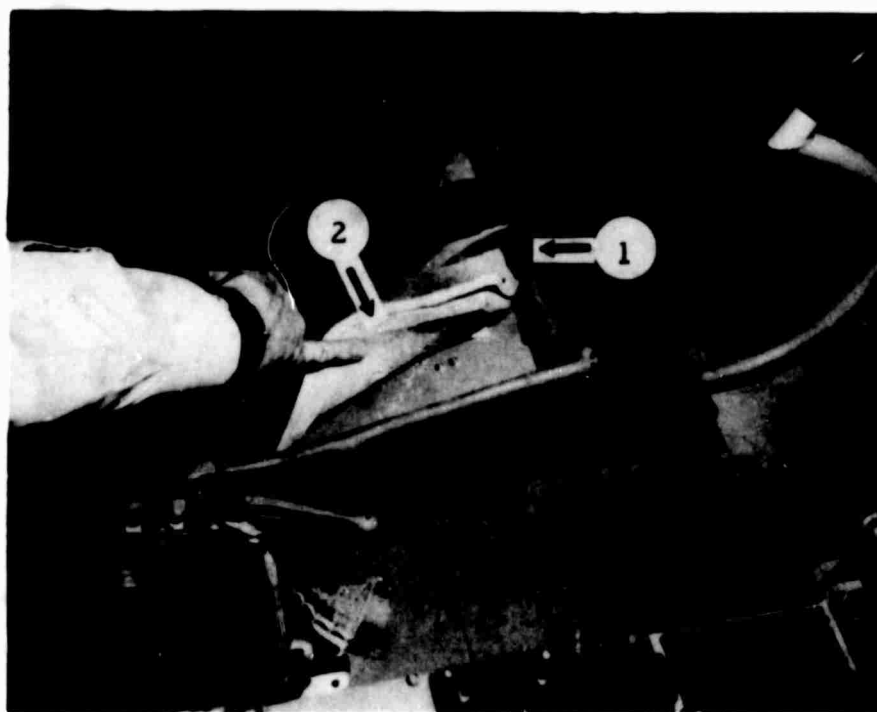
Figure 15. Copilot's seat. Forward edge of seat pan (1) padded with firm density foam rubber; foam rubber seat pan padding (2).

Arrow number 1 in Figure 15 shows the rolled, forward edge of the seat pan. Although padded with a firm density foam rubber, it presents an area for concentration of force to the underside of the thighs during vertical decelerations. This portion of the seat pan should be modified to provide a greater distribution of such forces to a larger area of the thighs.

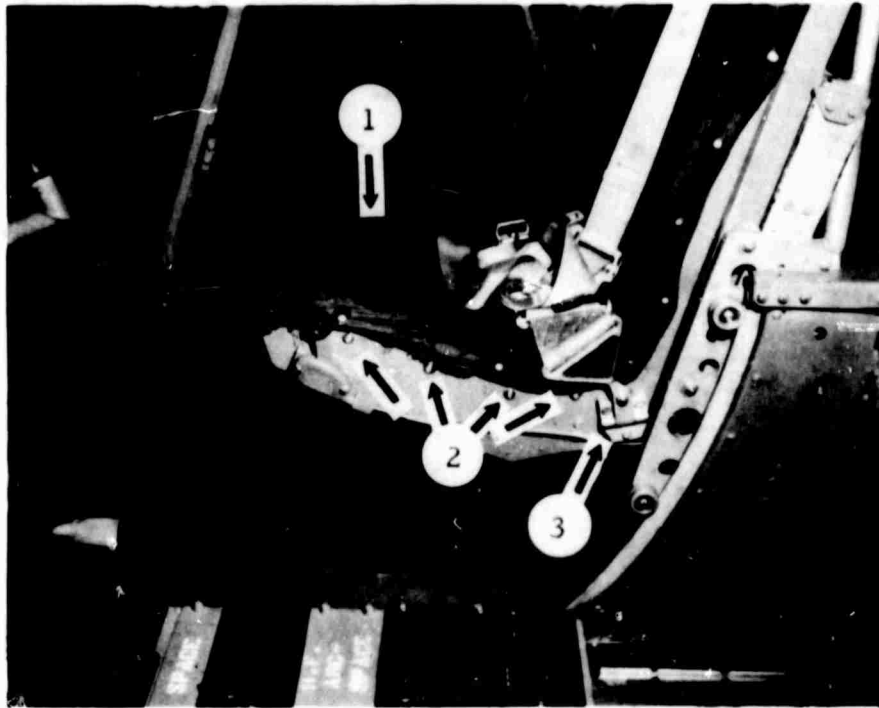
The nylon net material is fastened to the seat frame (Figure 16). During a crash, all snaps must be fastened to assure symmetrical loading of the seat pan material. Continuous maintenance will be required to insure that all snap fasteners are secured during flight.

Figure 16. Pilot's seat, showing nylon seat cushion material (1); open snap fasteners (2); and seat belt anchorage (3).

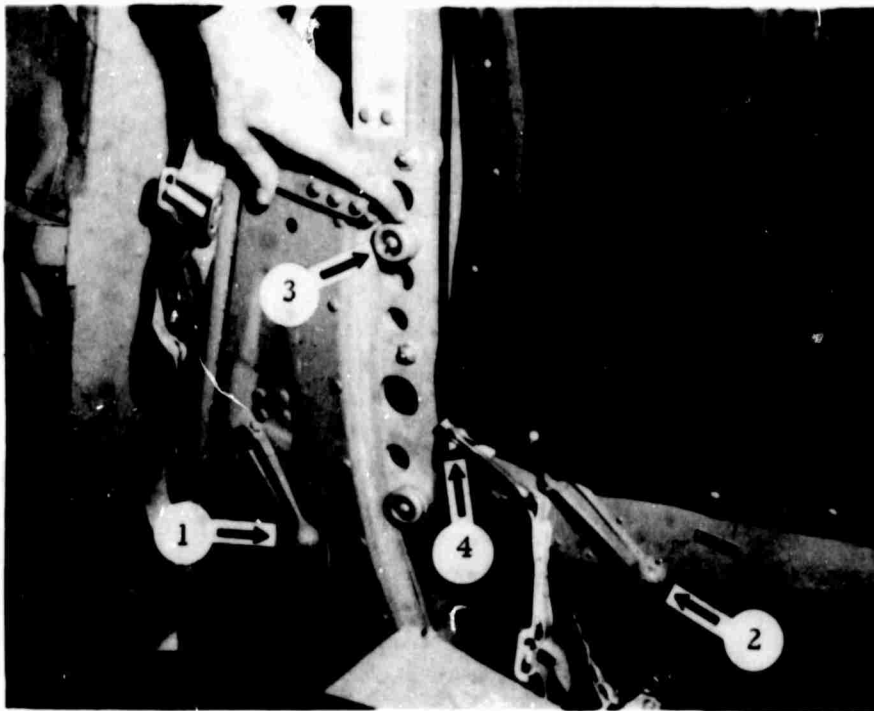
Figure 18. Copilot's seat tilt adjustment control (1); vertical adjustment control (2); tilt adjustment roller and track (3); safety belt anchorage (4).

Figures 18 and 19 illustrate the mechanism for raising, lowering, and tilting the seat. This exposed mechanism is capable of inflicting serious injuries to anyone placing his hand on it while the seat is being adjusted. This mechanism should be covered with a safety shield to prevent contact during seat adjustment.

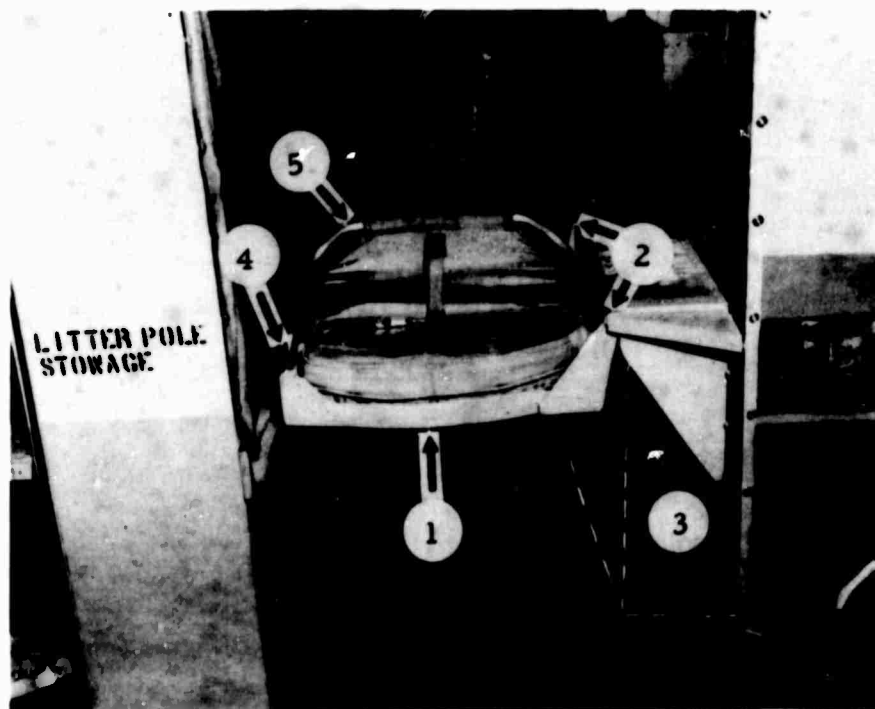
In the flight position (Figure 27) the occupant is restrained only by a seat belt. The lack of upper torso restraint will permit the occupant to be thrown against various items in his immediate environment during a crash, as illustrated in Figures 28, 29, and 30. The low seat back also could cause a serious back injury in the event this crew chief rebounded during a forward deceleration. This seating arrangement should be carefully studied and every effort made to provide the occupant protection at least equal to that of the pilot and copilot. A higher seat back, some sort of upper torso restraint, and padding of those surfaces within striking range of his head would provide such protection.

Figure 26. Crew chief/troop commander seat (looking forward) (1); hinge points (2); seat stowage area (3); seat pan snap lock (4); seat back (5).

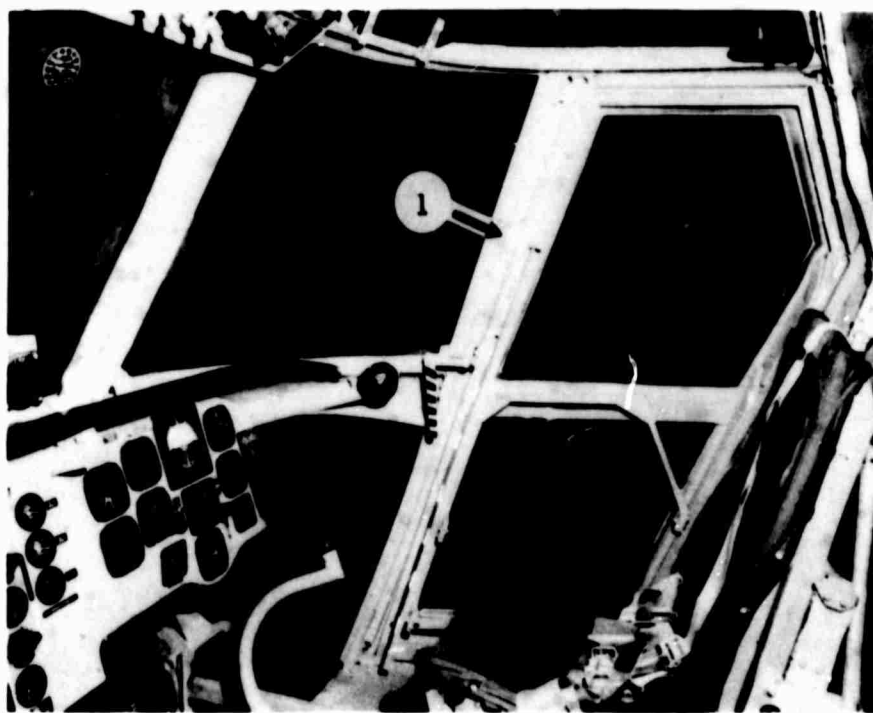
The exits are large enough and are considered adequate and readily accessible for quick emergency escape for all crew members even though the aircraft may roll on its side during an accident, blocking one of the exits.

Figure 31. Right side - pilot's environment. Jettisonable emergency door (1).

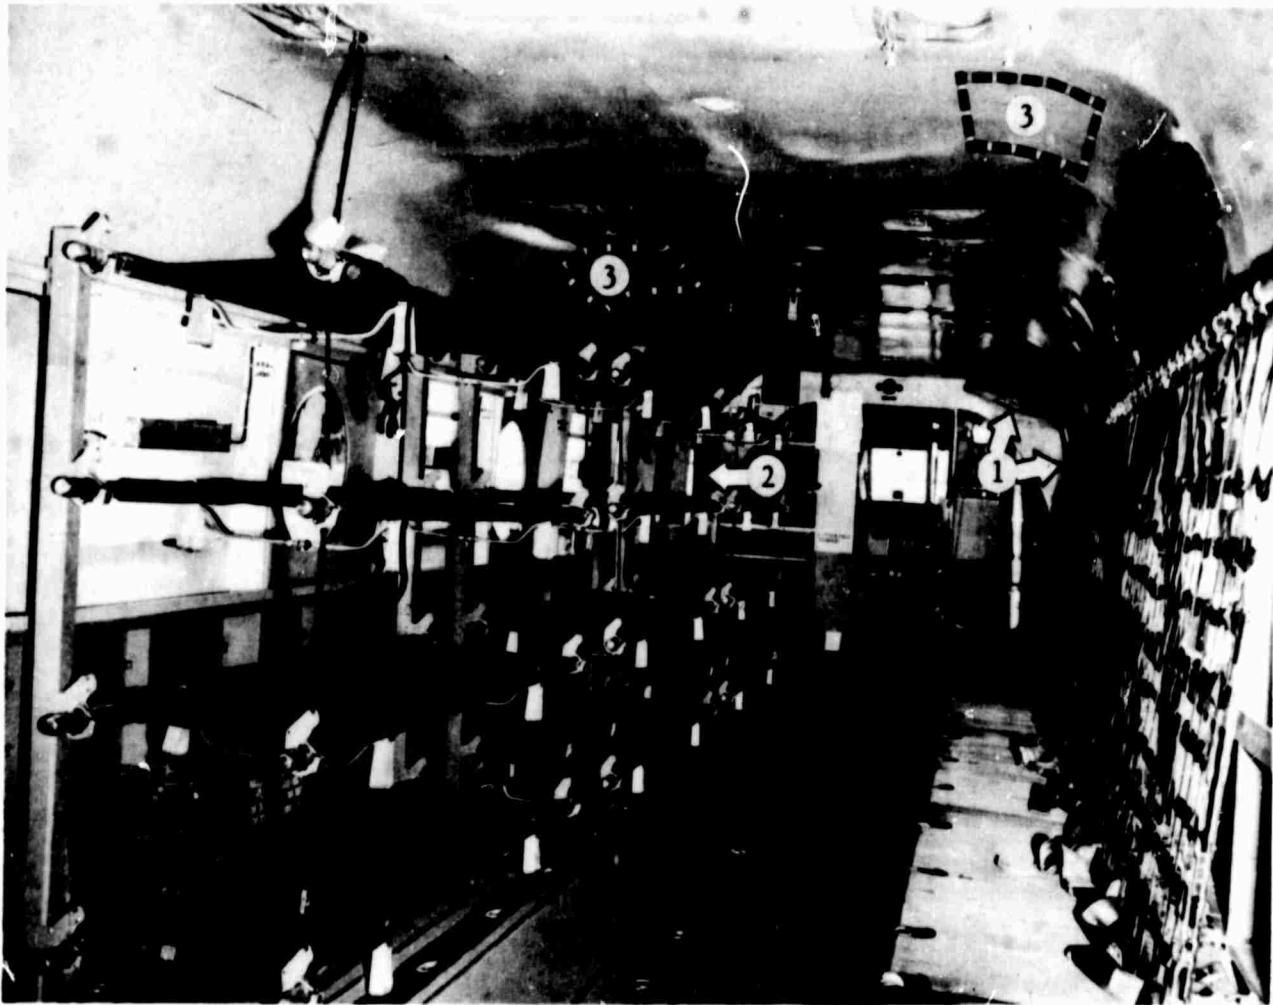
Figure 35. Main cabin of YHC-1B showing litter configuration on left side, troop seating arrangement on right. Main cabin door (1) is at forward end of cabin on right side; emergency exit window (2) is opposite main cabin door; possible location of recommended overhead emergency escape panels (3).

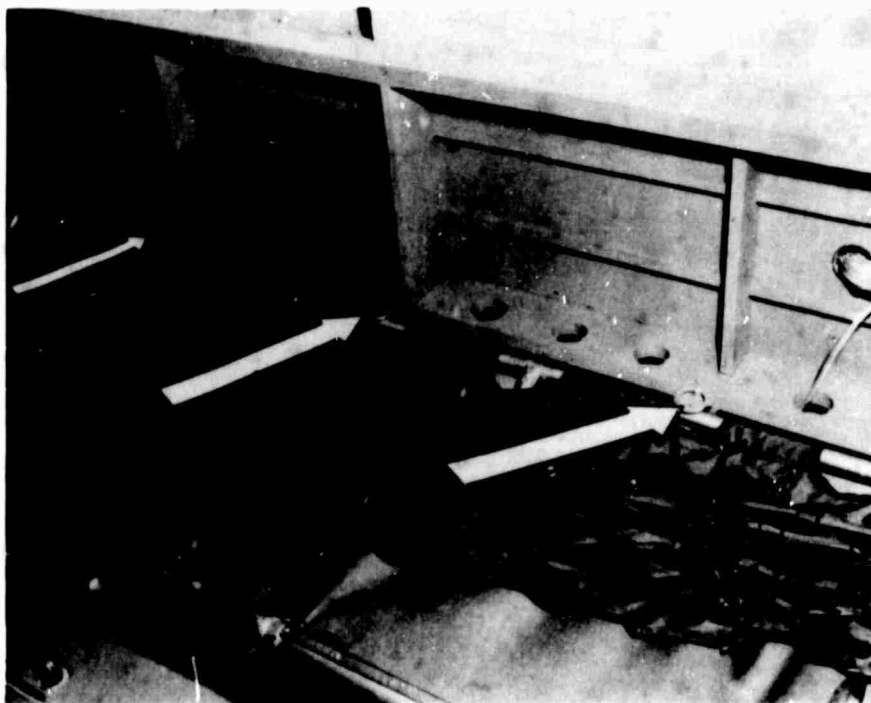
Seat belts, which provide the only means of occupant restraint in the seats, are anchored to "O" rings which are attached to the brackets supporting the rear seat support beam. The "O" rings are shown in Figure 43, and the manner in which the seat belts are attached to the "O" rings is shown in Figure 44. It will be noted that portions of two seat belts (the right belt of one occupant and the left belt of the occupant in the next seat) are anchored to the same "O" ring.

Figure 43. "O" rings at regular intervals between occupants (arrows).

Attention is invited to the manner in which the seat belts are attached to the "O" rings. Securing portions of two seat belts to a single attachment point (Figure 44) frequently results in failure of the anchorage due to the overload applied by two occupants. The seat belts, attached at points above the level of the seat pan, ride across the abdomen of the occupants (Figure 46).

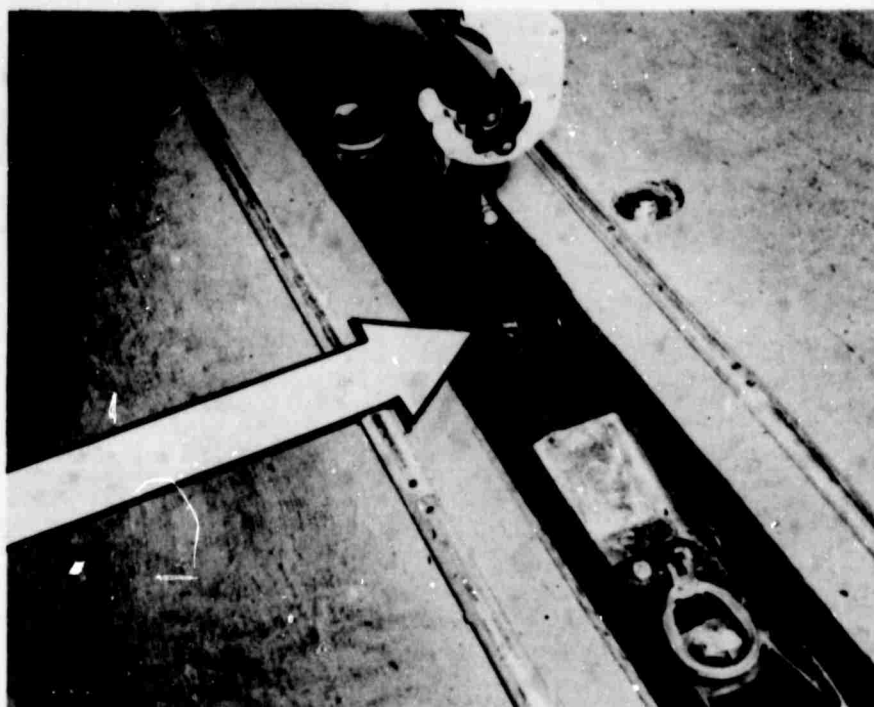
The litterposts are attached to studs in the upper seat support beam by means of a slotted anchor plate. The base of the post is attached to a floor anchorage. This arrangement is shown in Figure 49. The litter straps are anchored in the stowage compartment in the ceiling, as shown in Figure 50, and extend down to a floor anchorage, shown in Figure 51.

A fully loaded stack of four litters creates an overall load with a center of gravity much higher than is experienced with the troop seat configuration. This load is supported primarily along the upper beam (Figure 49-1) and in the overhead area (Figure 50). Considering that helicopter accidents are usually associated with more vertical and side loading than longitudinal loading, the current minimum strength requirements do not seem to be realistic or compatible with the conditions

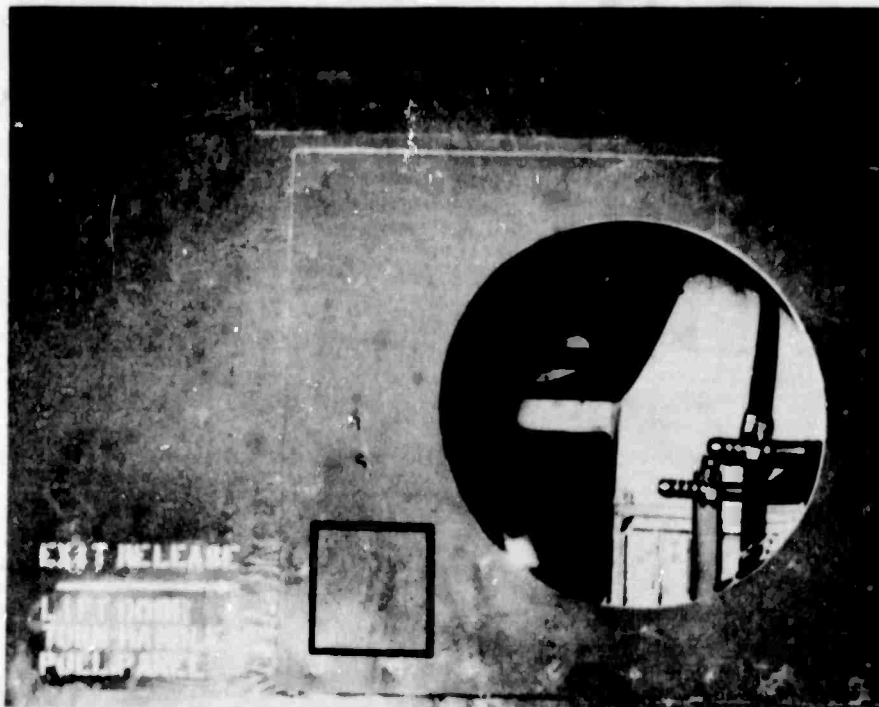
Three emergency exits are located in the main cabin area. One of the exits consists of the upper portion of the main cabin door, which is a 36 x 40-inch jettisonable panel. Figure 36-2 illustrates this exit. The forward left window, located opposite the main cabin door, is mounted in a jettisonable 24 x 30-inch escape panel. Figure 52 is an external view of this exit. The third emergency exit is located in the

Figure 52. Emergency exit window opposite main cabin door (24 x 30-inch jettisonable panel).

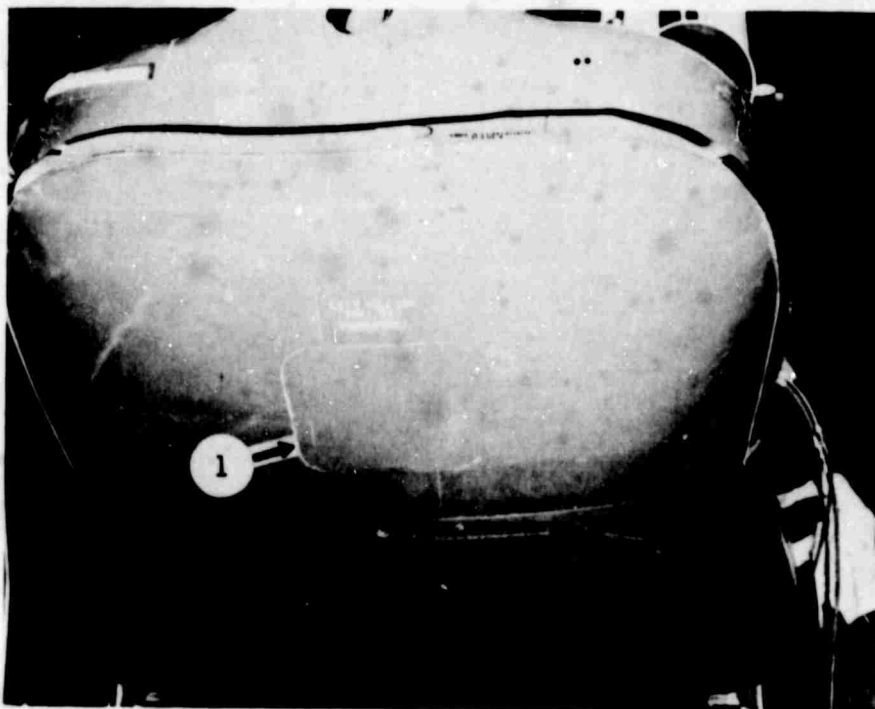
Figure 53. Loading ramp retractable cargo door. Emergency escape panel (1).

cargo door and is available for use when the loading ramp and cargo door are in retracted position. Figure 53 is an external view of the loading ramp showing the location of the exit. In addition to the three exits cited above, the third window from the front right-hand side of the fuselage is provided with markings "cut here". This window is located in an area which is free of heavy structural members and can be cut through with an axe from either the outside or inside of the aircraft to provide for an additional emergency exit. An external view of this area is shown in Figure 54. The hoist/rescue hatch in the center of the cabin floor (Figure 55) may be considered as a possible exit. Another possibility for escape is through the cargo door, if the door is opened prior to the accident or can be opened after the accident.

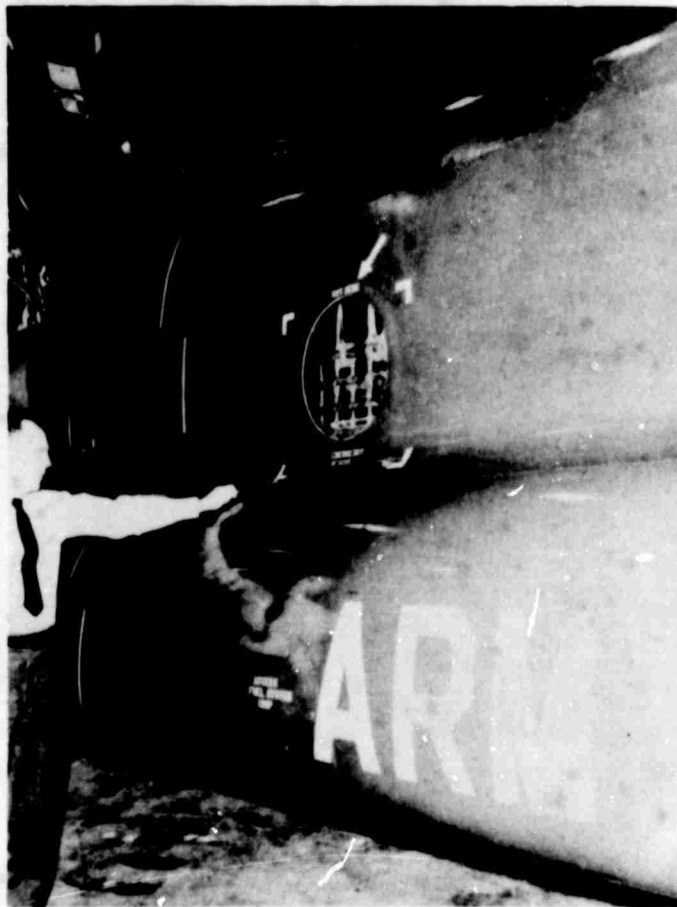
Figure 54. Third window on right side has "Cut Here" markings (emergency rescue area).

With reference to the one area provided for cutting through with an axe (Figure 54), it is noted that no crash axe has been provided. Utilization of this area as an exit would require removal of the troop seat back before the area could be cut through from the inside and used for emergency escape. There is no placarding in this window on the inside of the aircraft.

Based upon the foregoing, the emergency exits provided in this aircraft are considered inadequate to accommodate the number of troops to be carried in the main cabin section. At least two more emergency exits should be provided on either side of the fuselage at the location of the window marked "cut here" and a window directly opposite on the left side. In addition, at least two emergency exits should be located in the roof structure, as illustrated in Figures 35 and 59. All other windows in the aircraft should be designed so they may be kicked out and the openings utilized as emergency exits.

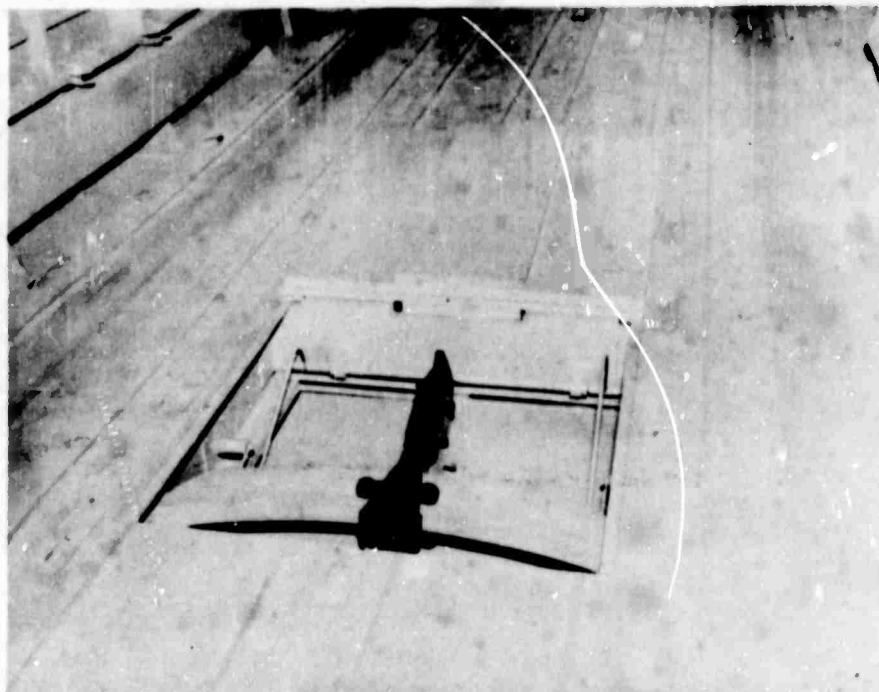
Figure 55. Hoist/rescue hatch in center of cabin floor.

A review of the emergency exits provided in this aircraft reveals that there are only three normal exits available. The cargo door might possibly be used as an exit; however, it should be considered only as a supplement, since it is questionable whether the door can be readily opened after the crash, and there is always the possibility of this door being jammed during the accident. If open prior to the accident, there is also the possibility of its being blocked by such items as the ramp extensions (Figures 56 and 57). Another supplementary exit is the hoist/rescue hatch in the center of the cabin floor; however, the equipment installed in this hatch would require removal prior to use. It is questionable whether time would permit utilization of this hatch as an emergency exit.

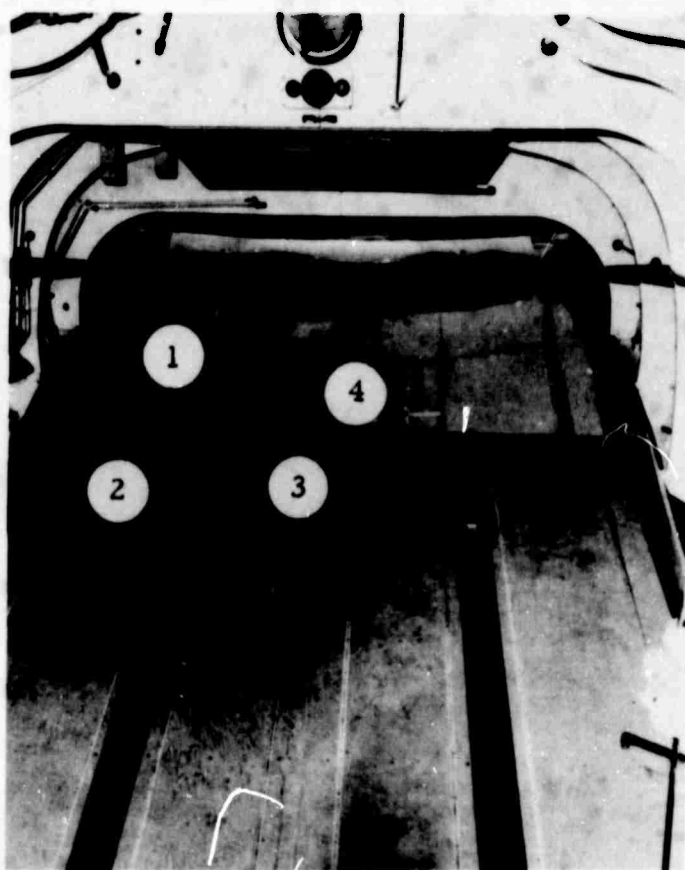
Figure 56. Cargo door (1) in closed position; ramp (2); ramp extension (3); emergency exit (4).

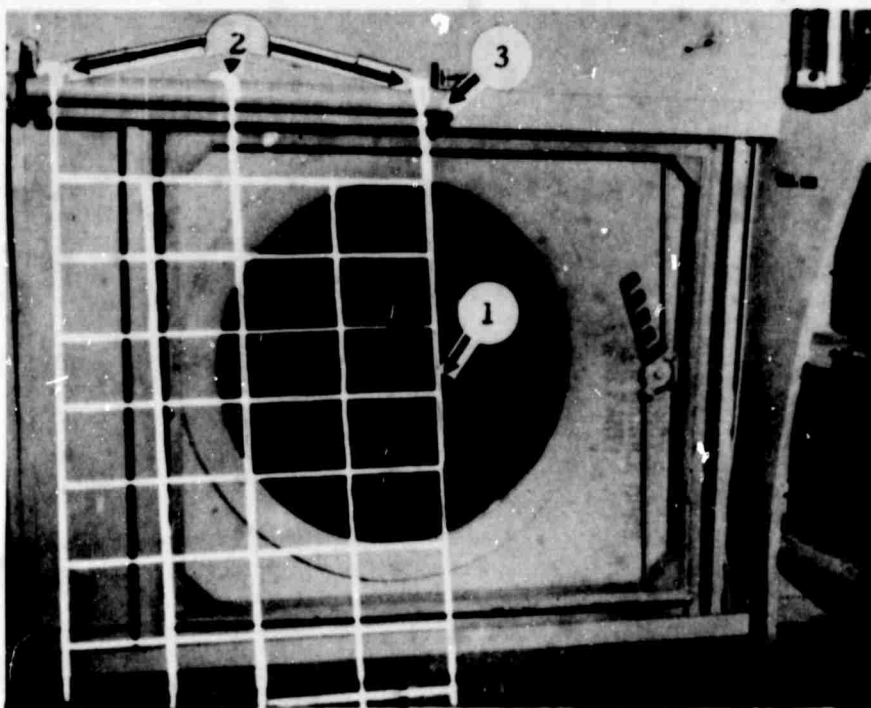
Figure 58. Front left cabin emergency exit (opposite main cabin door). Nylon troop seat webbing (1); upper attachments (2); upper beam (3).

Figure 58 illustrates the position of a troop seat partially blocking the emergency exit opposite the main cabin door. The time required to remove the troop seat webbing before the exit can be used in an emergency will further delay the evacuation of the troops.

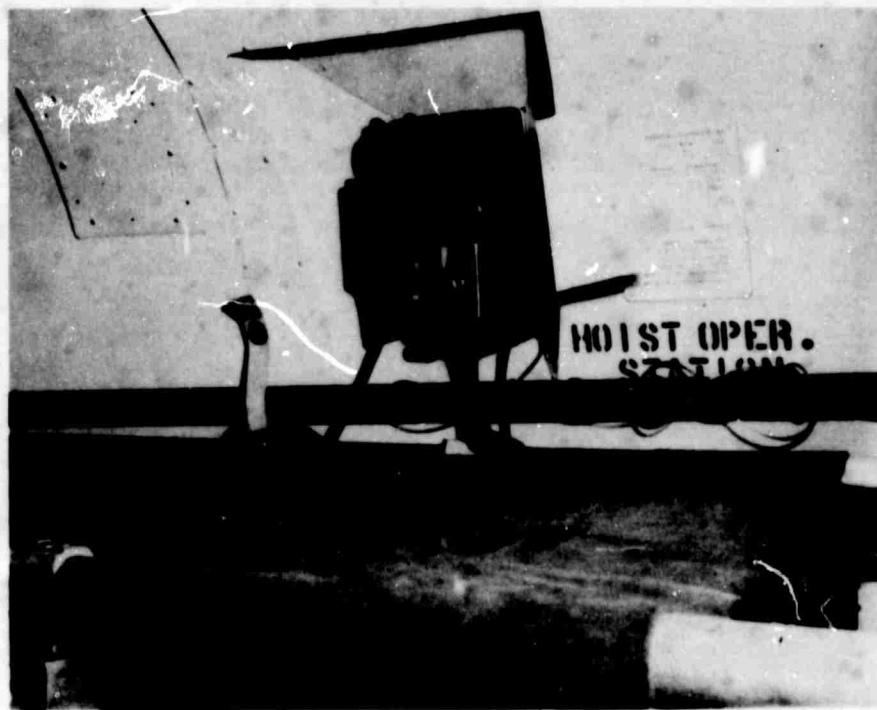
Figure 60. Recessed hoist operating controls.

The absence of significant protruding objects, which are generally noted in Army helicopters as injury-producing items in a crash, is a desirable crash safety design feature in this aircraft. Most of the cabin components and equipment installations are recessed (such as illustrated in Figure 60) or are out of striking range of the occupants.
